PHOTOGRAPHIC INTERPRETATION REPORT

**TYURATAM
MISSILE TEST CENTER
LAUNCH GROUP M**

AUGUST 1966

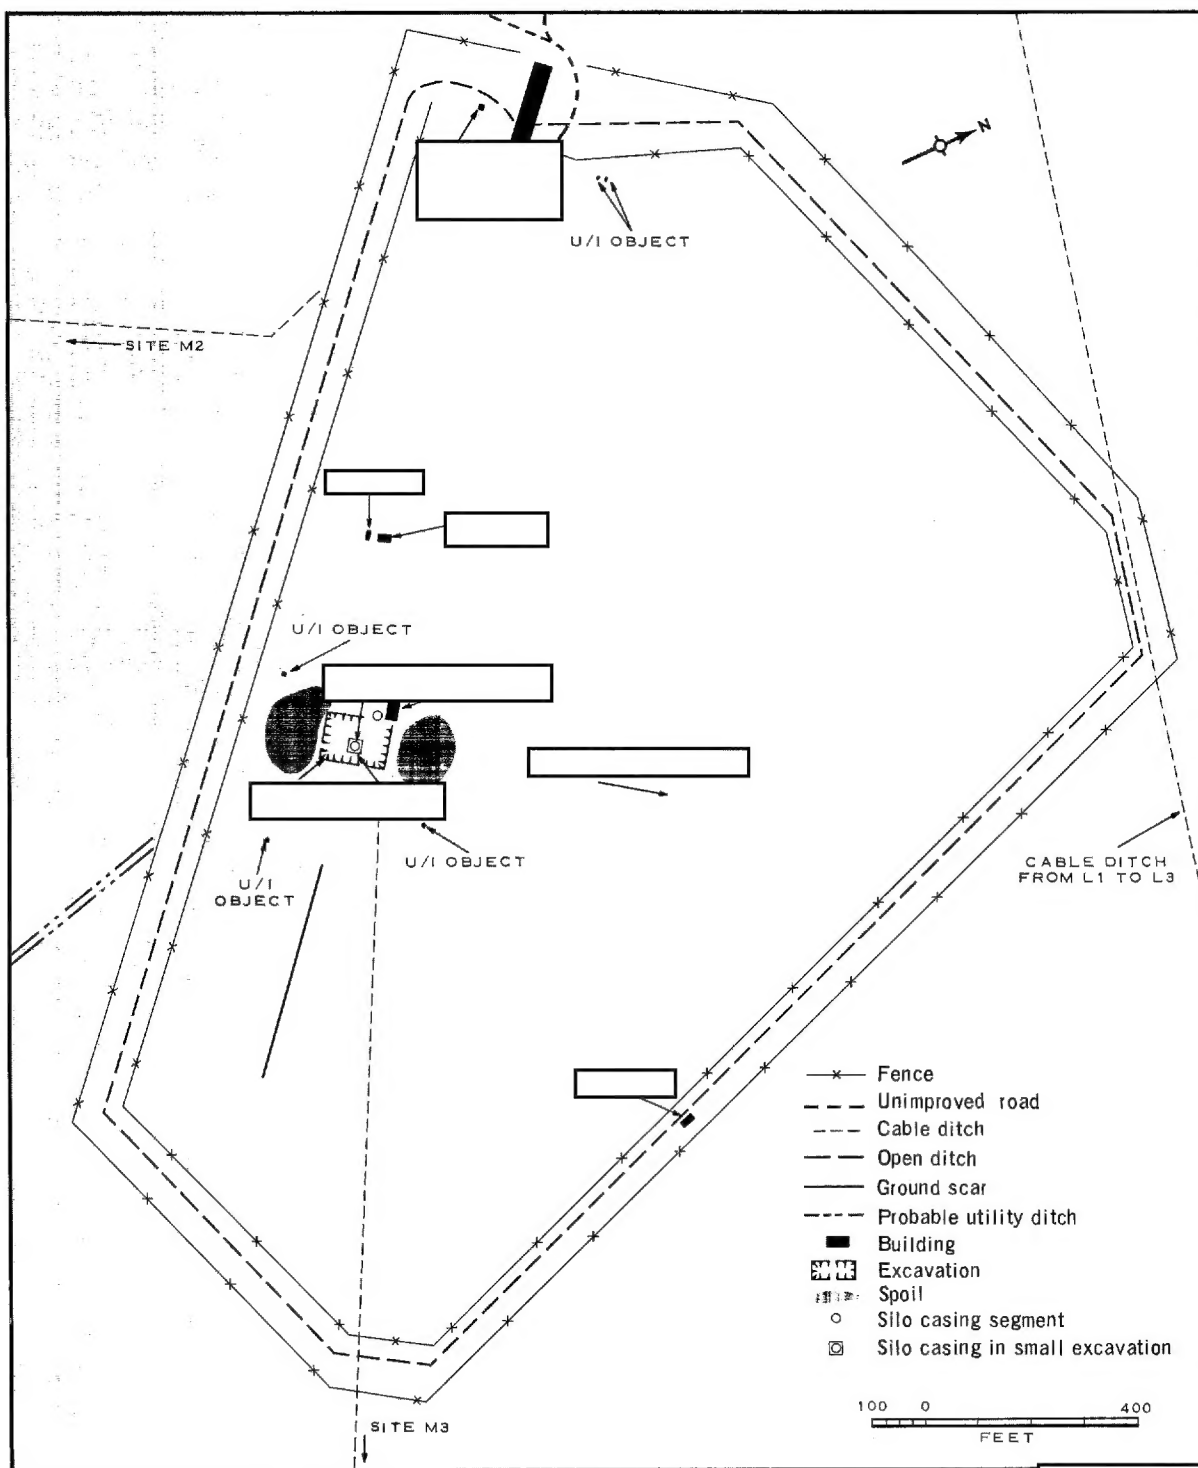
FIGURE 3. LAYOUT OF LAUNCH SITE M1.

A double security fence in the general shape of a triangle encloses the site. The shape and size of the area enclosed by the fence is similar to Soviet single-silo sites which have associated L-shaped electronic facilities, however no evidence of such construction has been identified. The silo is under construction in a rectangular excavation near the southwest fence-line; spoil from the excavation has been piled at the ends of the long axis of the excavation which is oriented on an azimuth of approximately

At that time the legs of the plus intersected at the silo coring; only one leg of the plus, extending southeast from the silo, is now visible. A cut was made through the spoil pile at the southwest end of the excavation, apparently to facilitate placement of the plus-shaped ground scar. The silo coring appears to have been cased up to the level of the bottom of the main excavation, and a shallow square excavation has been dug around the top of the silo casing. A building has been constructed north of the silo, on the edge of the main excavation. The walls forming the long axis of the building extend beyond that portion of the building which has been roofed, suggesting that it eventually may be earth-mounded. The building is similar in appearance to those constructed near the Type IID silos of Launch Group L at Tyuratam. The alignment of the 2 probable utility ditches to this site and the cable ditch to Launch Site M3 indicates that they will terminate at or near the silo; the alignment of the cable ditch to Launch Site M2 indicates that it will terminate at or near the large building between the security fences at the entrance on the northwest side of Launch

Site M1. This building is similar to those observed at Type IIC single-silo sites at Tyuratam. A ditch, aligned approximately midway between the fences, circuits the site. It originates and terminates at the large building. On the east side of the site, adjacent to the ditch, a small structure is located between the fences. Grading and scraping away of plant growth is in progress between the fences on the southwest side of the site. A possible reason for the ditching, grading, and plant removal between the fences would be the installation of an electronic-sensing type of security device.

There are 2 small buildings just northwest of the silo, and a small building just southwest of the large building at the entrance to the site. Three unidentified objects are in the vicinity of the silo excavation, and 2 more are near the fence line at the entrance to the site. Unimproved roads, formerly providing access to a borrow pit, traverse the site in an east-west direction. These are presently being used as site access roads pending completion of an improved road now under construction.

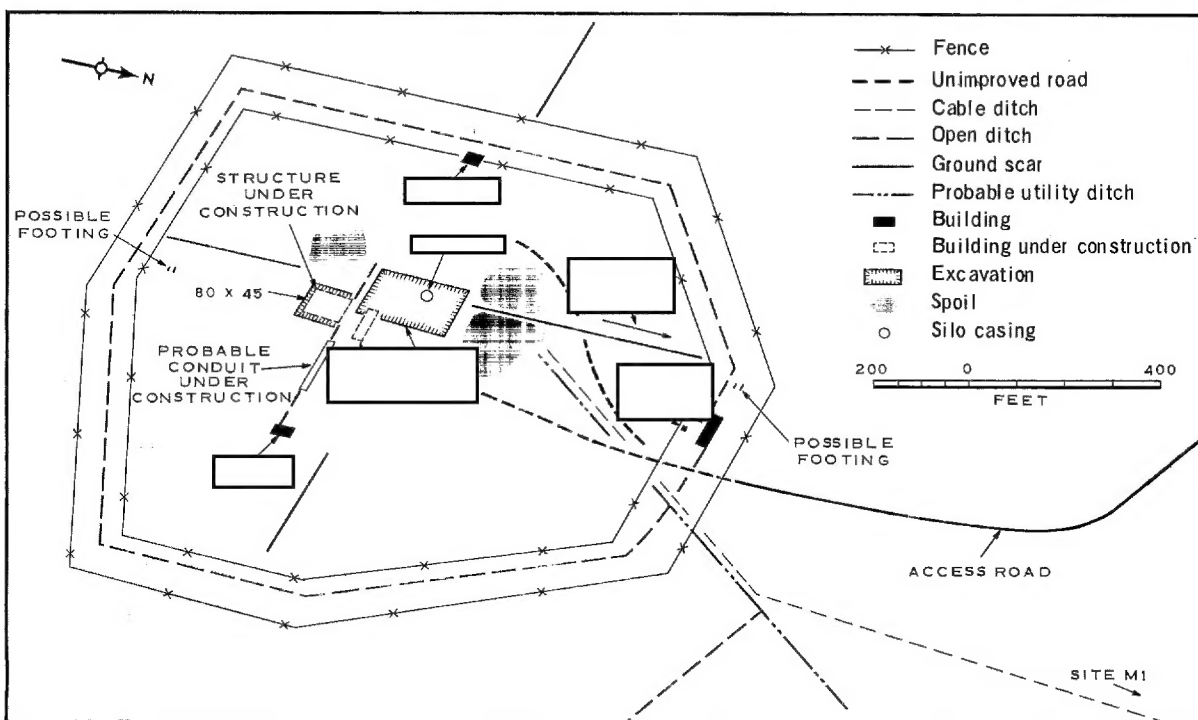
FIGURE 4. LAUNCH SITE M2.

An irregularly shaped, but somewhat rectangular, double security fence encloses the site. The silo is under construction in a rectangular excavation near the center of the site, and spoil from the excavation has been piled north and southwest of the main excavation. The long axis of the excavation is oriented on an azimuth of approximately [] A plus-shaped ground scar is superimposed on the site, with the intersections of the legs centered on the

silo. A cut has been made through the spoil pile north of the main excavation, apparently to facilitate placement of the plus-shaped ground scar. The silo coring appears to have been cased up to the level of the bottom of the main excavation. A building, which appears to be similar if not identical to the one at Launch Site M1, is under construction southeast of the silo on the edge of the main excavation. A rectangular structure is under construction in an excavation at the southeast corner of the main excavation. From a point near the rectangular structure, a probable conduit under construction in a ditch extends eastward toward a second smaller rectangular structure. The cable ditch from Launch Site M1 and the probable utility ditch enter Launch Site M2 on the north side and their alignment indicates they will terminate at or near the silo.

A building located between the security fences on the west side of the access road is similar in appearance to those observed in similar positions at the Type IIID sites of Launch Group L at Tyuratam. A ditch which circuits the site, aligned approximately midway between the fences, originates and terminates at this building. A small square building is located just to the south, adjacent to the inner security fence. The area between the fences has been graded, and plant growth has been scraped away. A small rectangular structure is located west of the silo, along the inner fenceline. Two small shallow excavations with possible footings in them are located just west of the building at the entrance to the site, and 2 more excavations are located near the southern fenceline. The access road to the site is completed to the security fence.

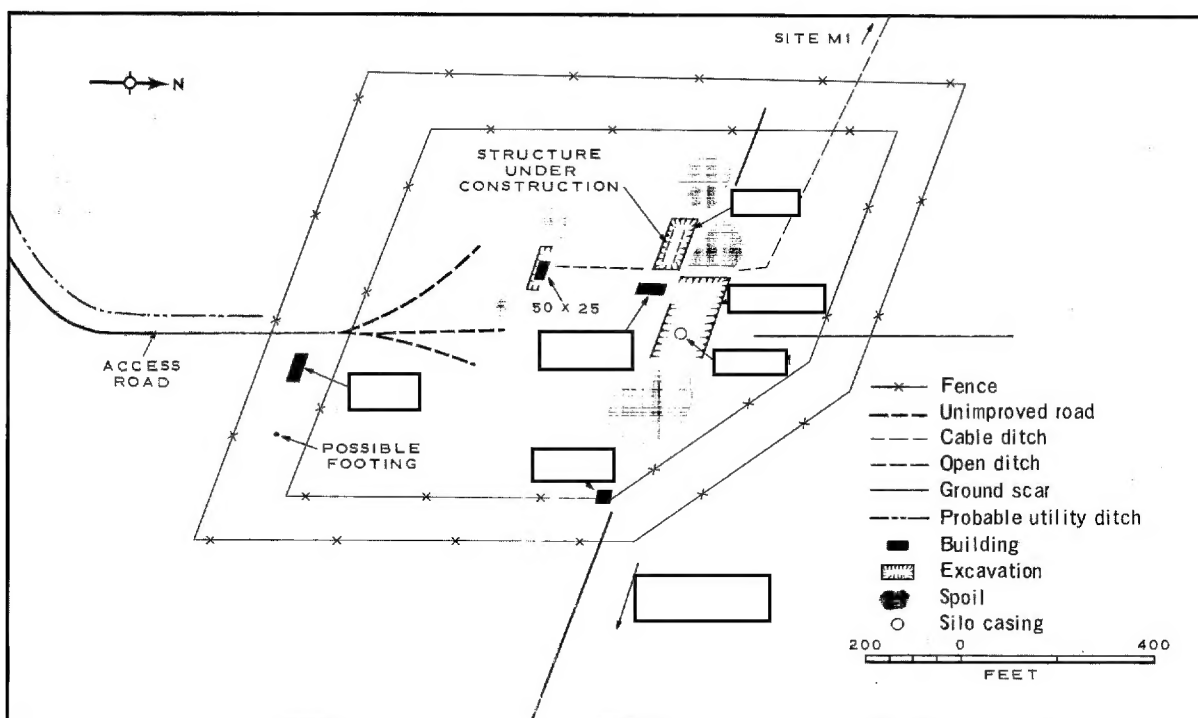
FIGURE 5. LAUNCH SITE M3.

A generally rectangular double security fence encloses the site. The silo is under construction in a rectangular excavation offset toward the north end of the secured area. Spoil from the excavation is piled at the east and west ends of the main excavation. The long axis of the excavation is oriented on an azimuth of approximately [REDACTED]. A plus-shaped ground scar superimposed on the site was visible when the site was in an earlier stage of construction in [REDACTED].

The intersection of the legs of the "plus" is centered on the silo. On the latest usable coverage [REDACTED] the southern leg of the "plus" is not visible. The spoil piles at the ends of the main excavation were not cut through for the placement of the plus-shaped ground scar, as they were at Launch Sites M1 and M2. The silo coring appears to have been cased up to the level of the bottom of the main excavation. A building, similar if not identical to the one at Site M1, has been constructed southwest of the silo on the edge of the main excavation. A rectangular structure is under construction in an excavation at the southwest corner of the main excavation; spoil is piled on the west side. A ditch extends southward from the structure under construction to a second, smaller rectangular structure in a shallow excavation. Spoil is piled to the west and southeast of the latter structure.

The cable ditch from Launch Site M1 enters Launch Site M3 at the northwest corner and can be traced to the northwest corner of the main excavation. The probable utility ditch to the site parallels the north side of the access road and follows the alignment of the road as it curves northward into the site. The road is im-

proved to the fenceline. A building located between the security fences on the east side of the access road appears to be identical to one in a similar position at Launch Site M2. A small excavation with a possible footing in it is located to the rear of the building. A small square structure is located along the inner

fenceline east of the silo. The area between the fences has been graded, and plant growth has been scraped away. Although no ditch such as those observed at Launch Sites M1 and M2 has been identified, one could have been back-filled prior to the grading between the fences.
